# ANALYSIS OF HAZARDOUS EXOGENIC PROCESSES IN THE “AMIRSOY” RESORT AREA WITHIN THE CHARVAK FREE TOURIST ZONE

**Abstract.** *This study presents a comprehensive geographical analysis of hazardous exogenic processes occurring within the “Amirsoy” resort area, located in the Charvak Free Tourist Zone, and its adjacent mountain slopes. Based on integrated field investigations, interpretation of aerospace imagery, GIS-based spatial analysis, and cartographic materials, the spatial distribution, morphological characteristics, and driving factors of landslides, slope failures, rockfalls, gully erosion, and debris-flow processes were systematically evaluated.*

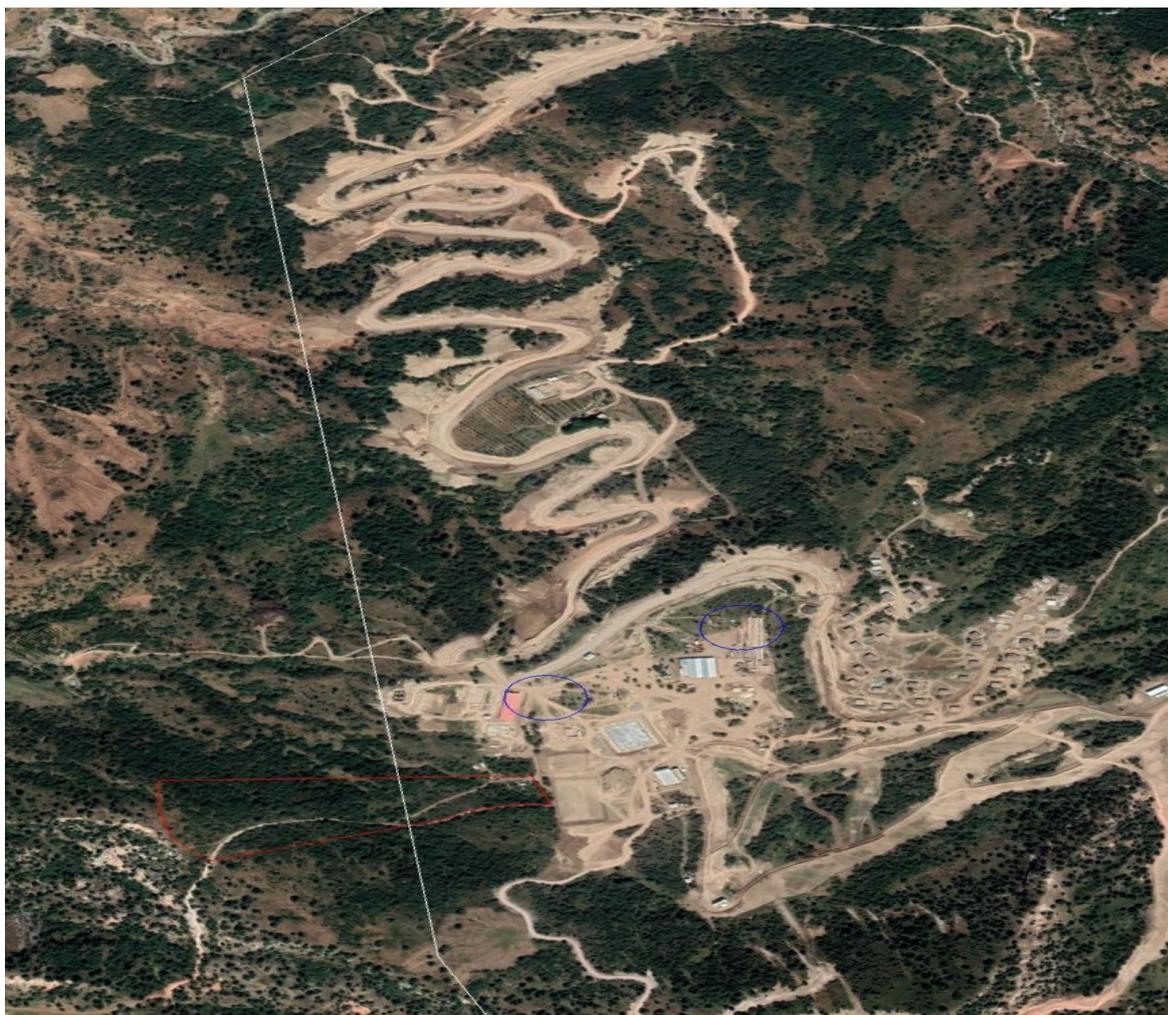
Figure 1.

The Amirsoy resort was built for skiing and active mountain tourism in winter and for providing tourists with recreational and recreational tourism services in the warmer months. (Figure 1).
