MULTI-STORY FRAME REINFORCED CONCRETE BUILDING

SEISMIC TESTING OF THE MODEL

ANNOTATION: This article presents the results of testing a building model for seismic impact to determine the dynamic characteristics of a nine-story frame building made of monolithic reinforced concrete. When testing the model for seismic impact, the "load drop" method was used.

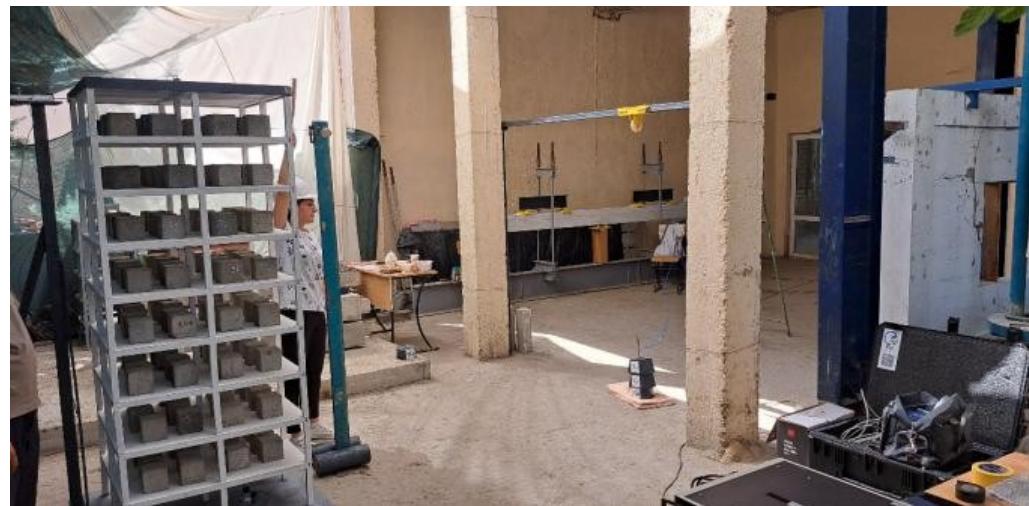
The test circuit was carried out as follows. The building model, in addition to its own weight, was loaded with temporary vertical loads, and its dynamic characteristics in free oscillations were determined using measuring instruments (Fig. 2). This process was repeated three times. The graphs obtained during the testing are presented in Fig. 3.

Fig. 2. From the test process.¹

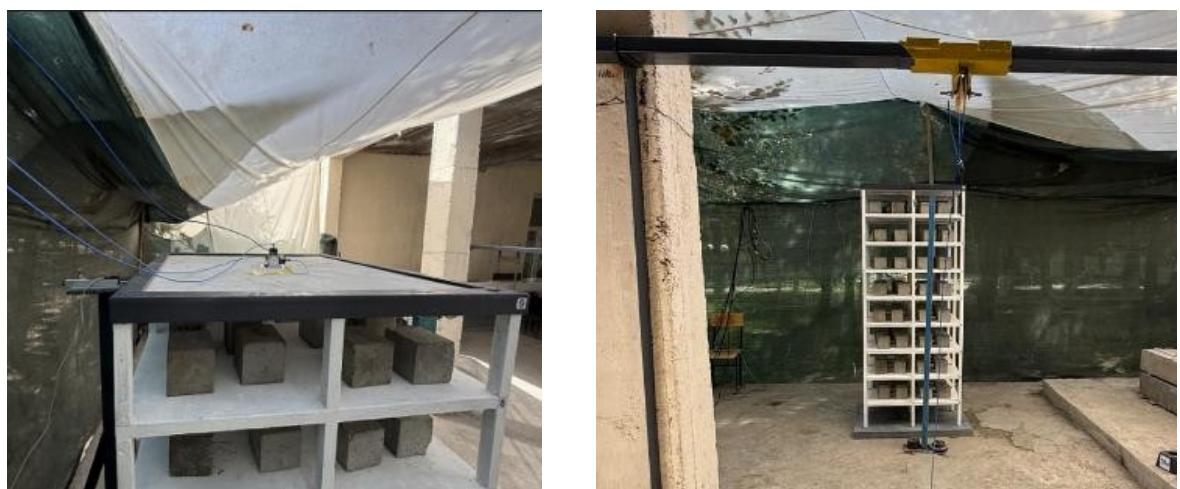
In addition to its own weight, an instantaneous seismic impact was imitated on a building model loaded with temporary vertical loads using the "Throwing the Load" method, and its dynamic characteristics in the state of forced oscillations were determined using measuring instruments (Fig. 3).

Figure 3. View of the model with instruments.

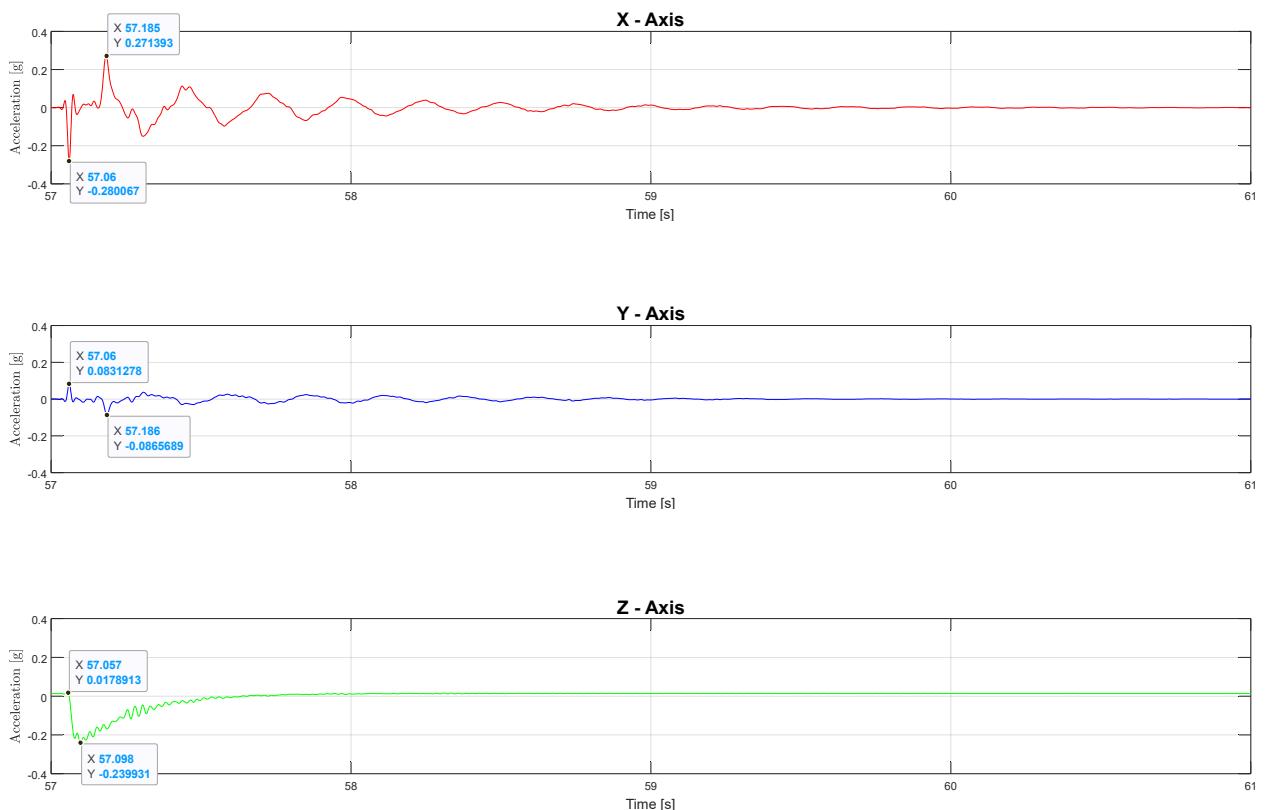
Results from a sensor placed on the floor level of the 1st floor
 Accelogram X, Y, Z

Spectral power density X

Figure 8. Accelogram and displacement of the building when it is pulled from the top with a force of 40 kg* using a cable and released.

Based on these accelerograms, a Power Spectrum Density (PSD) graph was constructed, and the average frequency of the building is presented in Table 1.
